APRIL 2025

THE ENGINEERING QUARTERLY

2 Engineer or Detective? Uncovering the True Cause of Vessel Bracket Failures

Engineer or Detective? Uncovering the True Cause of Vessel Bracket Failures

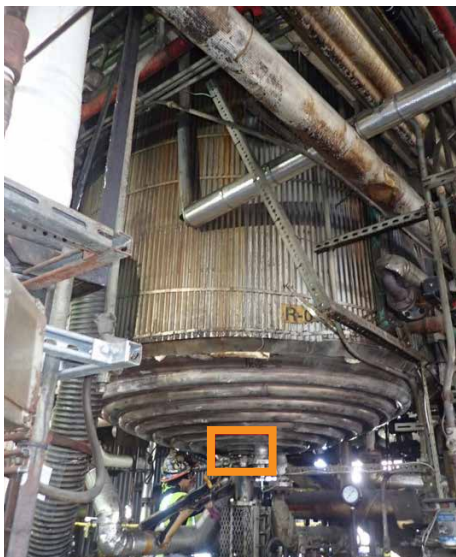
Fig. 1 - Overview of vessel and lower head with boxed area highlighting the region of interest.

A chemical processing vessel was experiencing a persistent and costly problem. This 8-foot diameter by 12-foot tall vertical vessel, used for batch processing of amine products, had an agitator shaft running through its center. At the bottom of the vessel, a steady

bearing bracket secured the shaft. This critical component was failing repeatedly, with cracks forming at the bracket welds on a nearly annual basis.

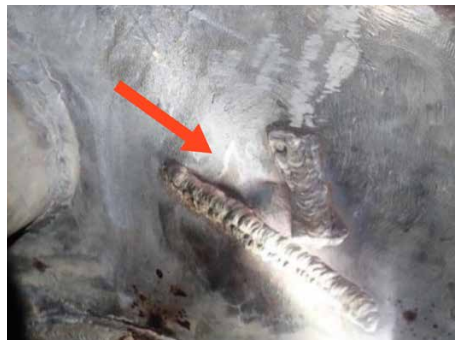
Fig. 2 - External surface of vessel head showing multiple weld repairs and visible deformation (arrow).

In multiple instances, through-wall cracking occurred, leading to forced shutdowns and emergency mobilization of a welding crew to perform repairs. This incurred repair costs and lost production opportunity costs. The client assumed that forces from the

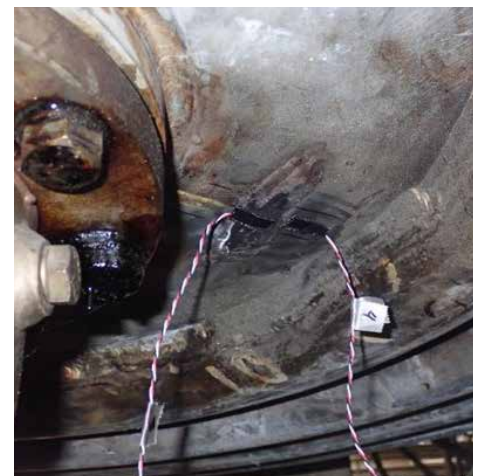
Fig. 3 - Strain gauge placement on vessel bottom head.

“We ended up working with a local Acuren NDT office and used ultrasonics to measure from the outside the exact location of the bracket on the inside so we could apply strain gauges at the correct location,” Rutledge said.

With this information, the team installed strain gauges on the vessel’s exterior directly beneath the internal bracket welds. They monitored the equipment through a complete production batch cycle, capturing real-time stress data from all operational modes.

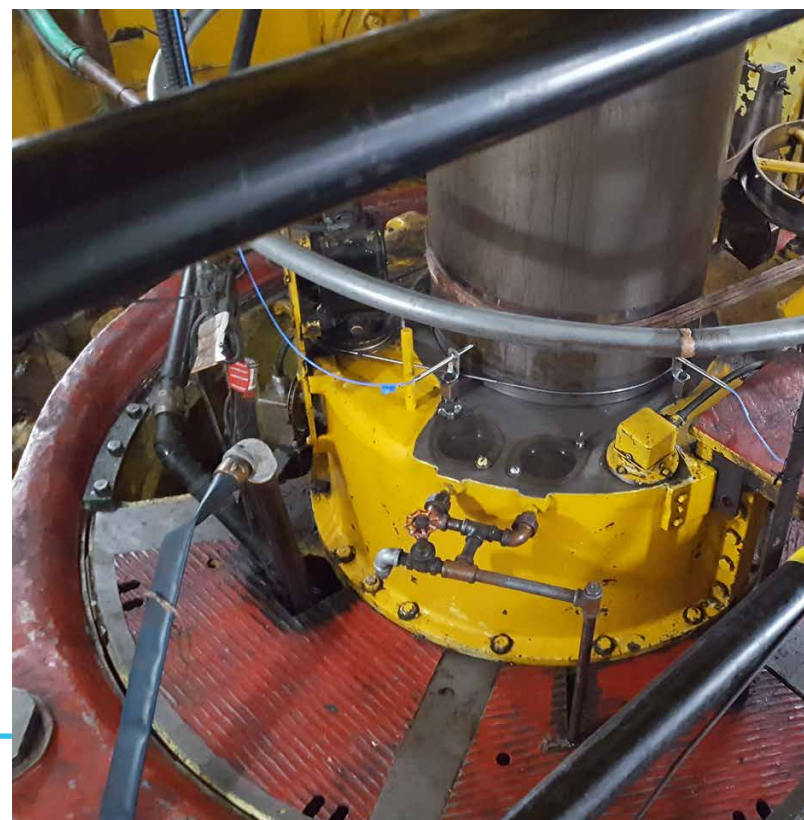
Fig. 2 - Reference 1x vectors, "As-Found"

As with any balance process we need to assess the initial or "As-Found" condition. Figure 2 is a representation of the 1x vectors (amplitude and phase) at load increments of 10% wicket gate open. The guide / thrust bearing indicates a number of load conditions that exceed the target but some would also exceed trip parameters (refer to ISO 20816-5), whereas the turbine 1x vectors are within the target displacement amplitude. The guide / thrust bearing exhibits an average light spot vector much larger than the turbine bearing, and the requirement to average both turbine and guide/thrust vectors should be continuously assessed during the process.

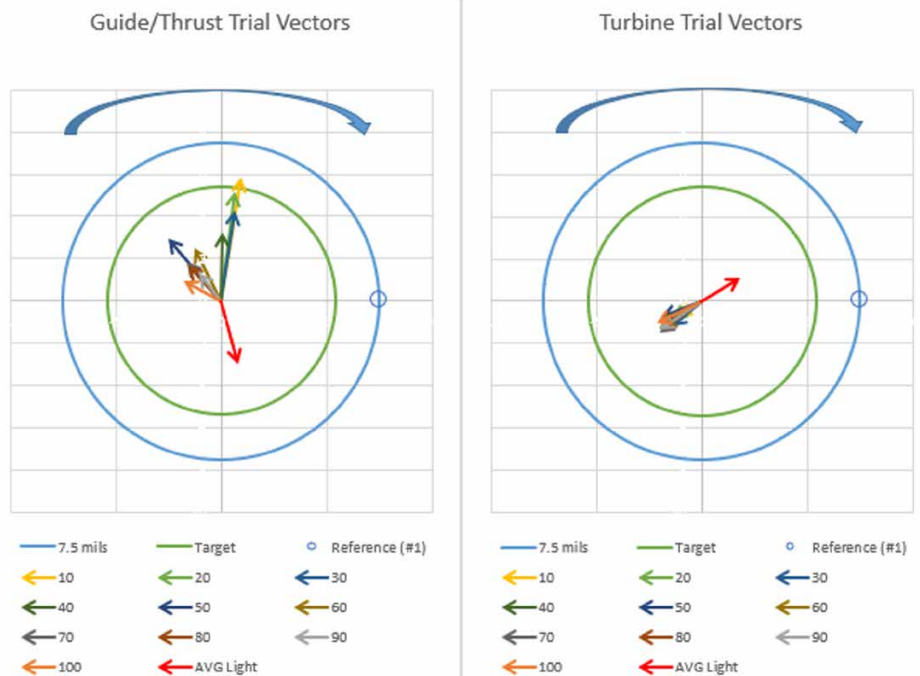
Fig. 3 - Trial 1x vectors

The results of the trial mass observed in Figure 3 indicates 1x vectors at all loads are within the displacement target, except guide/thrust bearing 1x vector at 10% gate.

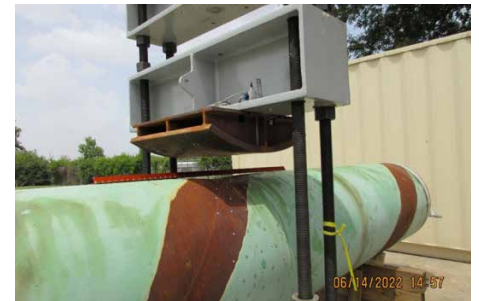
Fig. 1 - Dent installation test rig

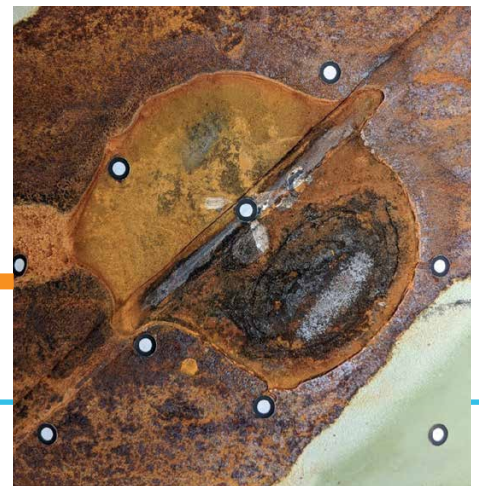
Figure 2 shows a photo of a dented test sample along with a fatigue crack that developed in the shoulder of the dent after approximately 10,000 pressure cycles were applied.

Fig. 2 - Failure of pressure cycled dent

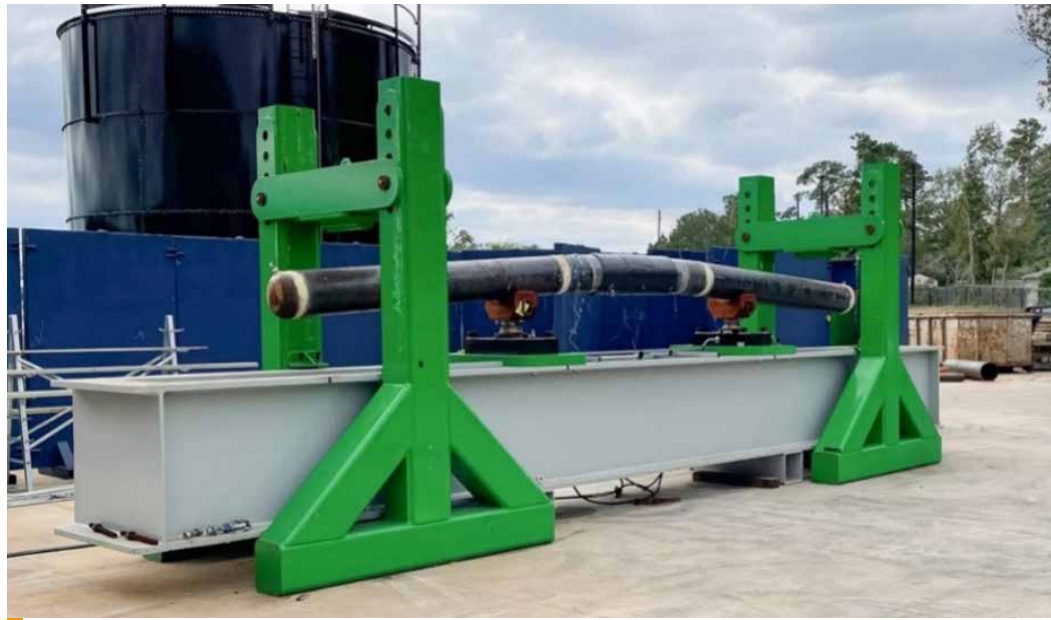
Fig. 4 - 4-point bending frame

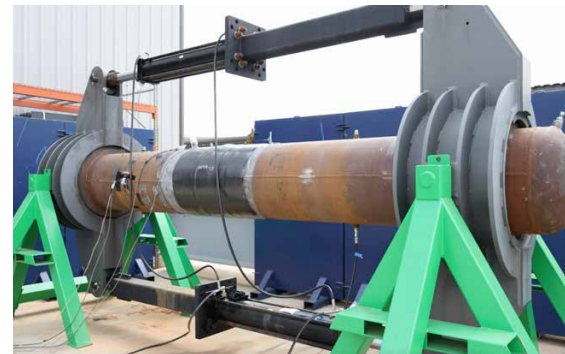
Fig. 5 - High strain bending frame (800,000 ft-lb capacity)

Provided in Figure 5 is a photograph of Acuren's high strain-low cycle fatigue frame with a bending capacity of 800,000 ft-lbs. Testing wrinkle bends is an effective method for quantifying the number of cycles a wrinkle feature can survive before leaking. Once this value is determined pipeline operators can determine if geohazard loading in a particular region might generate similar conditions.

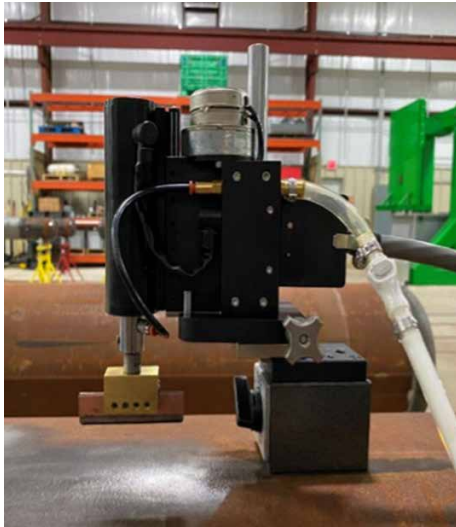
Fig. 6 - Machine used to install EDM notch

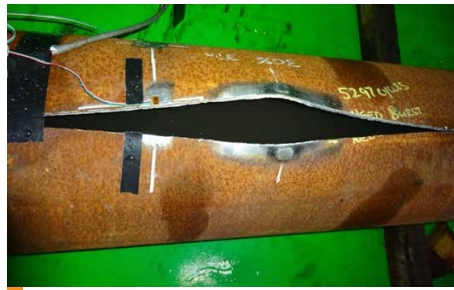
Fig. 8 - Burst test of sample having a crack-like defect

There are several approaches for testing cracks in pipe samples. One involves testing cracks in pipe materials removed from service. The other option, and the one more often used in full-scale testing, involves the creation of cracks generated by pressure cycling notches installed via EDM. Figure 6 includes a photograph of an EDM machine used to install notches. Figure 7 includes a macrograph showing a crack that initiated from an EDM notch. Testing involves either pressure cycling the samples until a through-wall crack develops or pressurizing the pipe sample until a burst failure occurs, as shown in Figure 8.
